PERIODIC REVIEW

**Brundage Bone Concrete Pumping
Facility Site ID#: 2251**

**1041 North 4th Avenue,
Kent, Washington**

December 2009

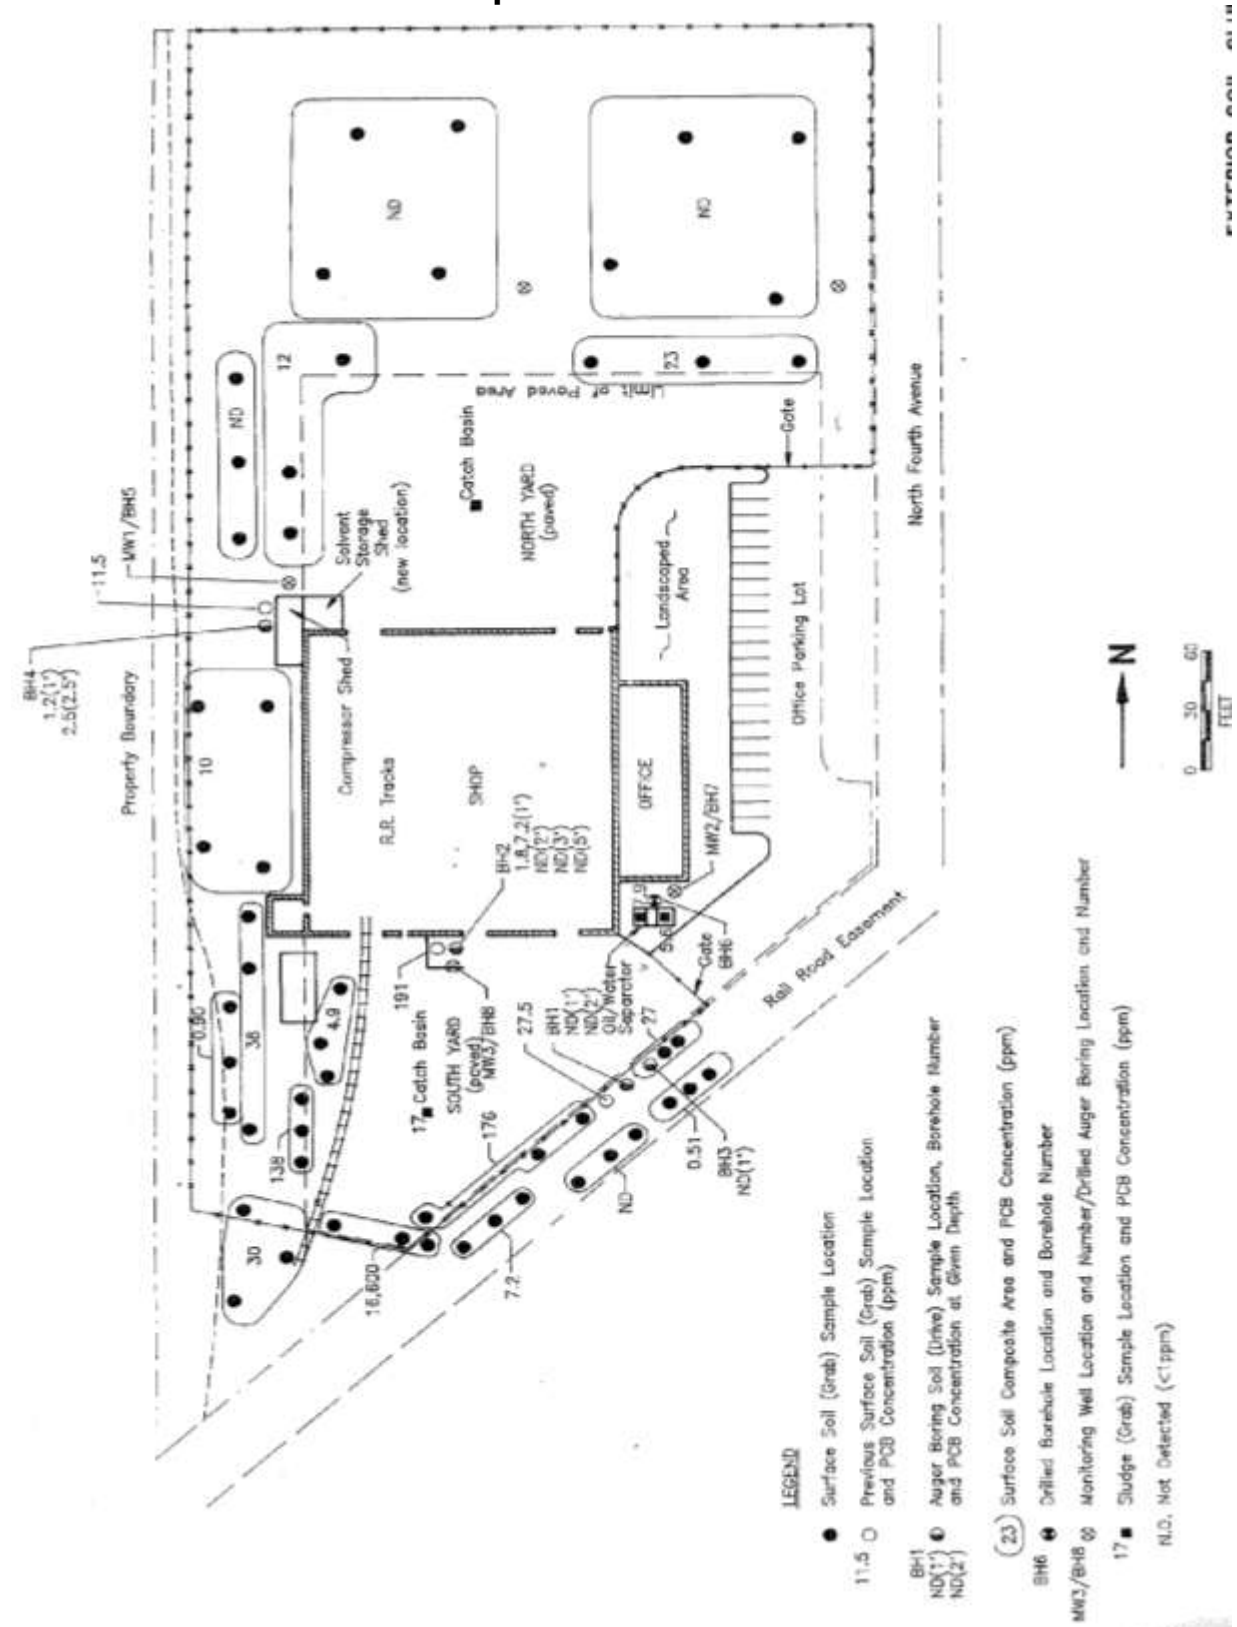
6.3 PCB Concentration Map

Portions of the Property may contain levels of polychlorinated biphenyl (PCBs) and / or chlorinated hydrocarbons and petroleum compounds. The potential locations of PCB impact are: The asphalt covering in the north yard and south yard areas; Soils in contact with the west-side foundation of the former GE Apparatus Service building; On the land immediately to the west of the former GE Apparatus Service building, at a distance of approximately 48 ft up to and including the fence boundary; The land west and south of the southwest building corner to a distance of approximately 144 ft south, and the land west and north of the northwest building corner to a distance of approximately 36 ft north; Beneath a shed-like structure on the northwest corner of the former GE Apparatus Service building; The west, south, and southeast border of the paved south yard area; and the west, north, and east border of the north yard area.
